RESERVE STUDY

Forest Glen Townhome Owner Association

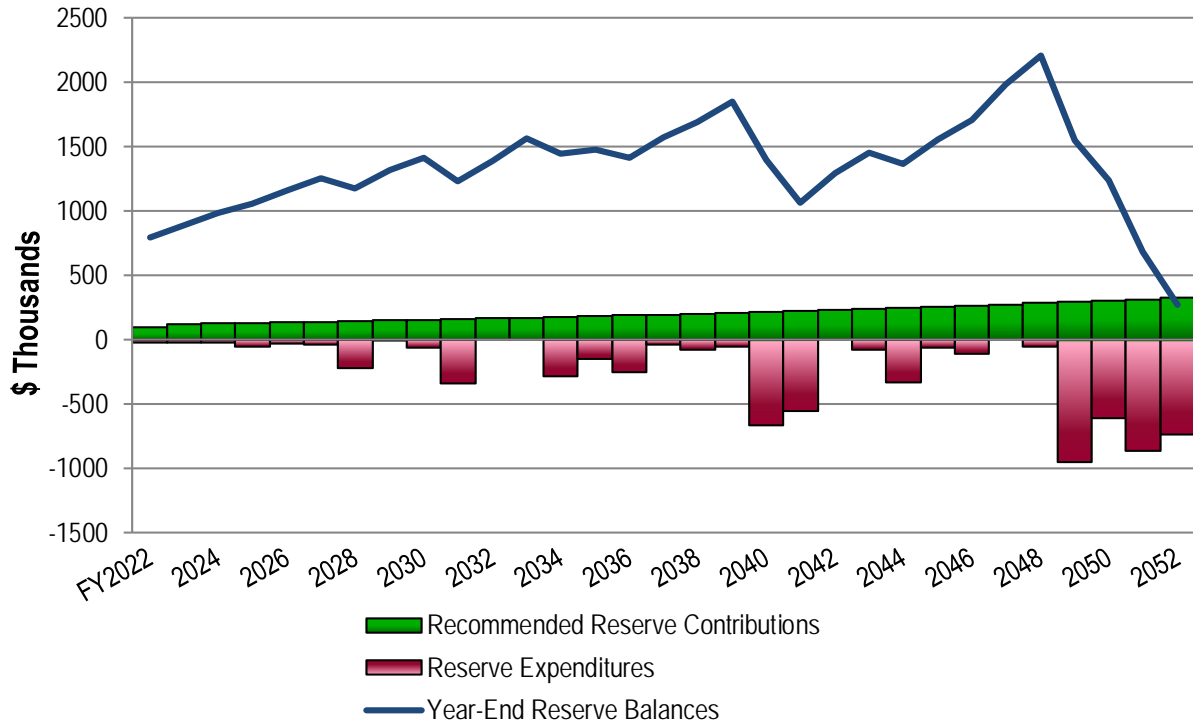
Year	Reserve Contributions (\$)	Reserve Balances (\$)	Year	Reserve Contributions (\$)	Reserve Balances (\$)	Year	Reserve Contributions (\$)	Reserve Balances (\$)
2023	119,000	884,558	2033	167,900	1,558,757	2043	236,800	1,449,165
2024	123,200	981,174	2034	173,800	1,445,490	2044	245,100	1,363,014
2025	127,500	1,052,415	2035	179,900	1,476,799	2045	253,700	1,554,931
2026	132,000	1,155,803	2036	186,200	1,411,782	2046	262,600	1,704,904
2027	136,600	1,253,403	2037	192,700	1,567,343	2047	271,800	1,978,361
2028	141,400	1,175,898	2038	199,400	1,691,740	2048	281,300	2,203,817
2029	146,300	1,317,595	2039	206,400	1,845,891	2049	291,100	1,544,682
2030	151,400	1,408,067	2040	213,600	1,393,697	2050	301,300	1,233,326
2031	156,700	1,226,154	2041	221,100	1,058,853	2051	311,800	680,525
2032	162,200	1,389,531	2042	228,800	1,288,709	2052	322,700	267,099

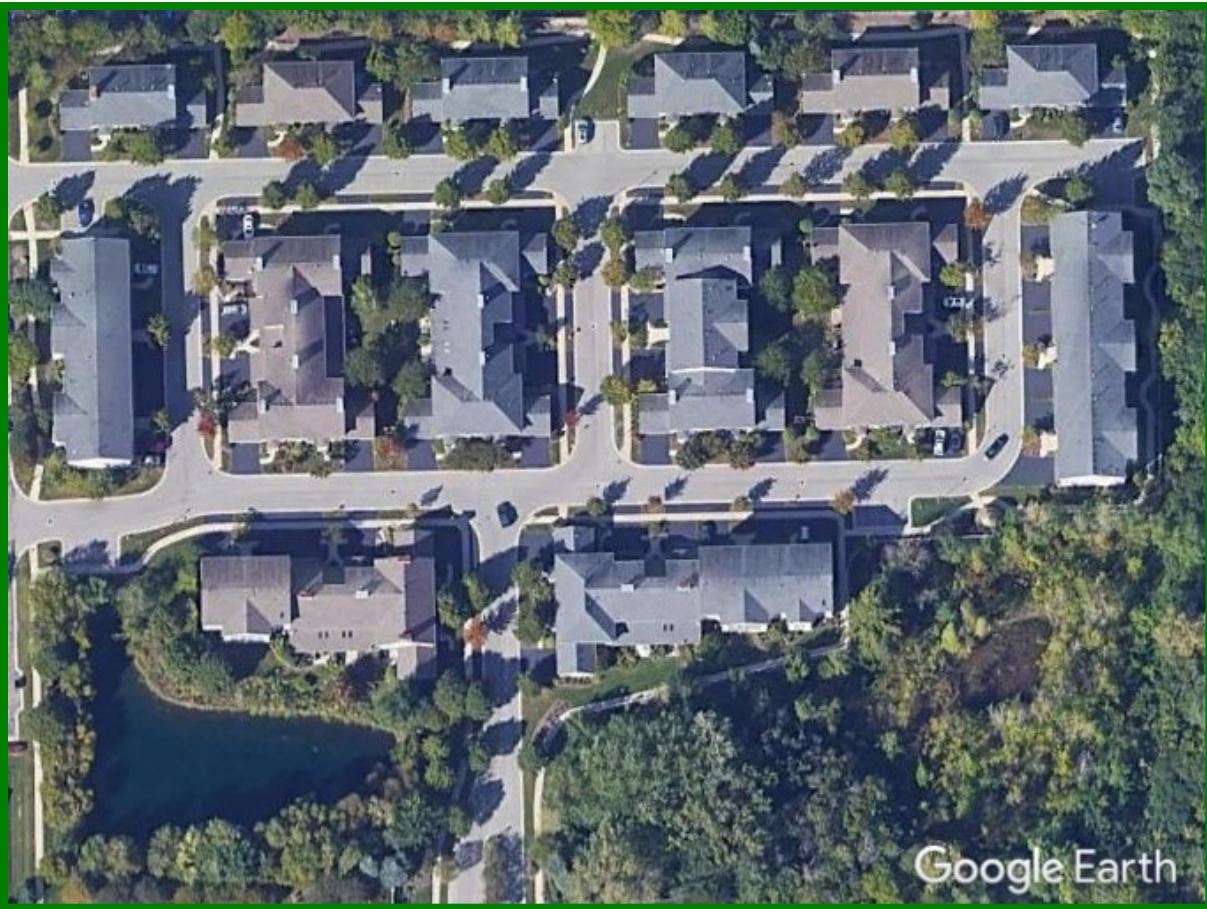
Our investigation includes Reserve Components or property elements as set forth in your Declaration. The Expenditure tables in Section 3 list the elements contained in this study. Our analysis begins by segregating the property elements into several areas of responsibility for repair and replacement.

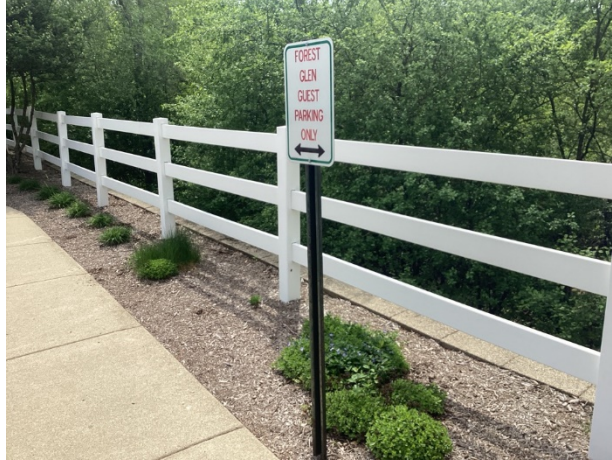
Typical information signage

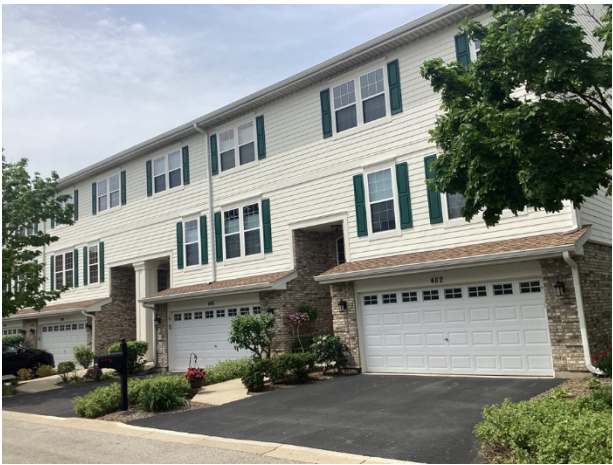
Exterior Building Elements

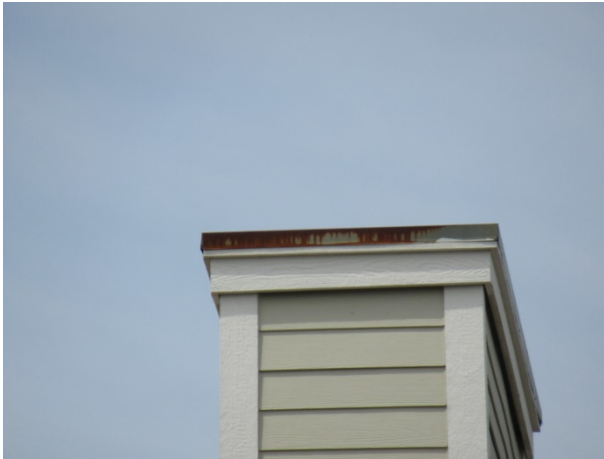
Condition: Fair overall, based on our visual inspection from the ground, with periodic rust evident.

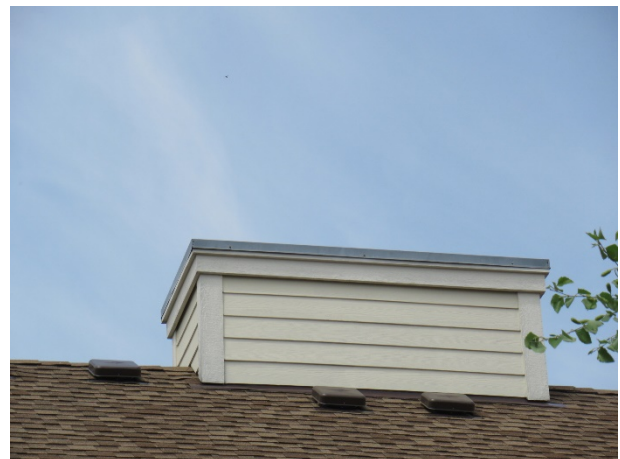
Chimney cap overview

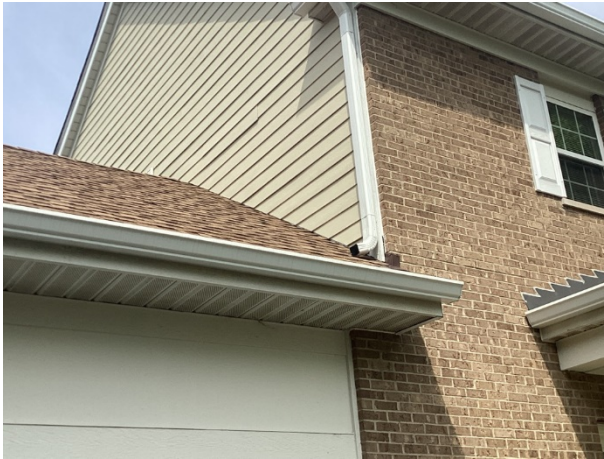
Downspout discharges directly to roof

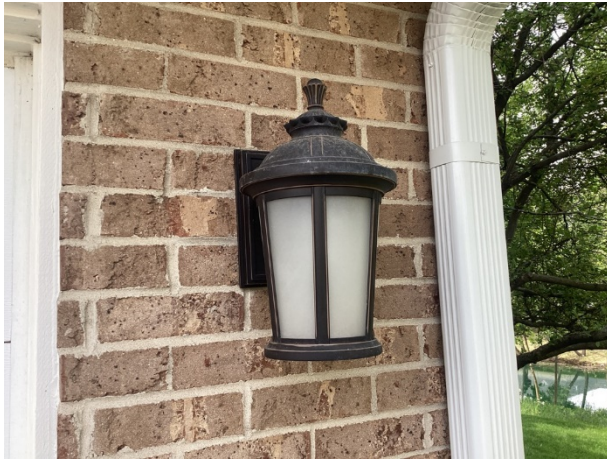
Garage light fixture

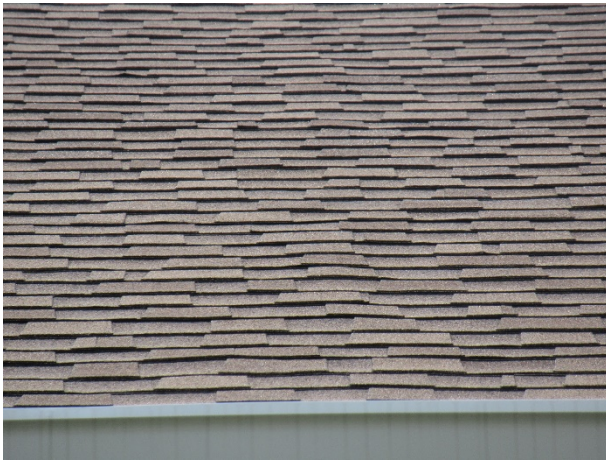
Condition: Good overall with no significant deterioration evident from our visual inspection from the ground.

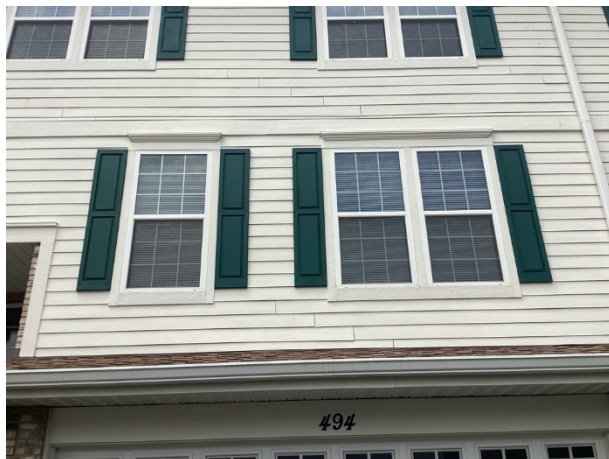
Typical vinyl shutters

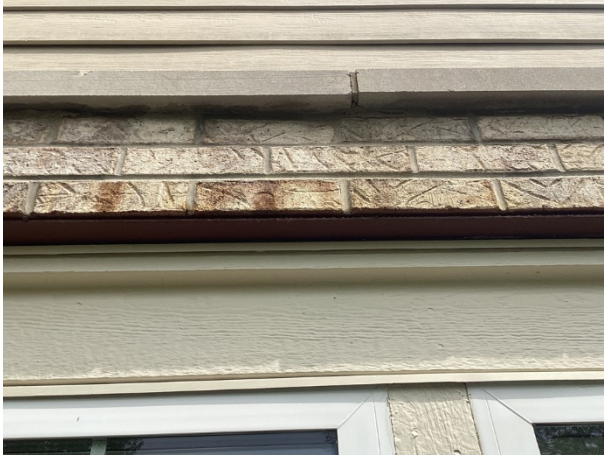
Condition: Good to fair overall with isolated efflorescence and lintel rust evident at the time of our inspection.

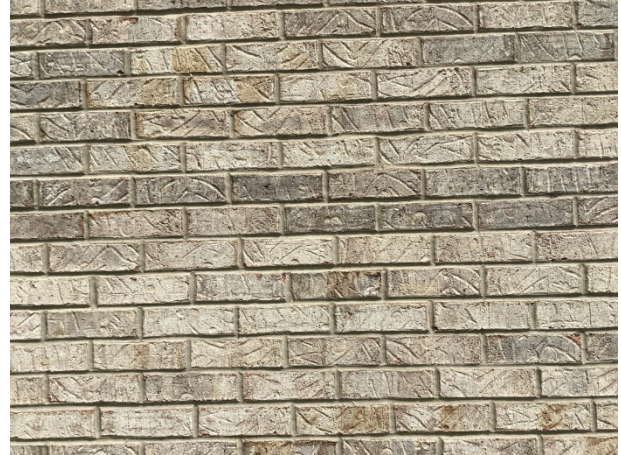
Masonry walls overview

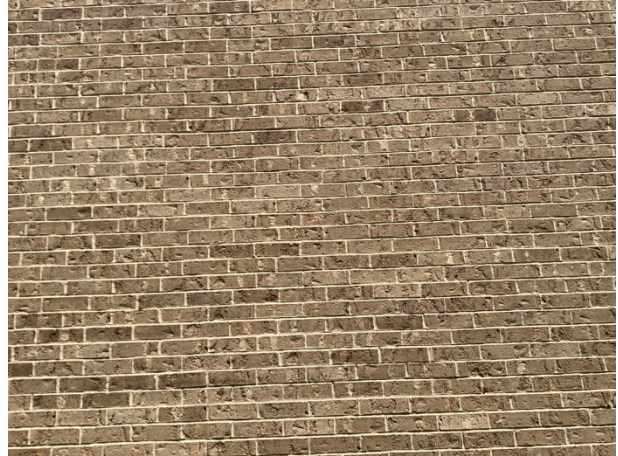
Masonry walls overview

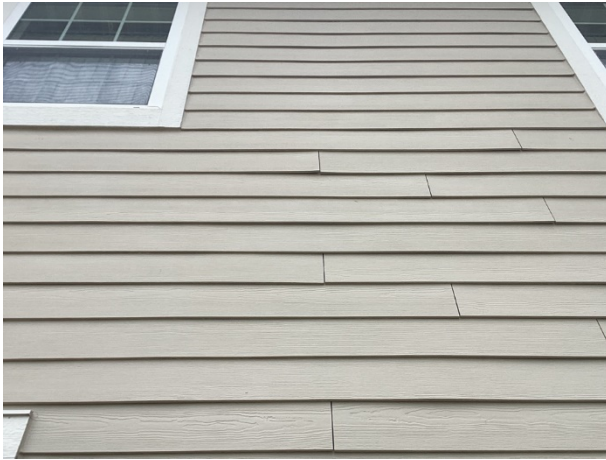
Condition: The siding is in good to fair overall condition and the paint finishes are in good overall condition with isolated finish deterioration, loose sections and deflection evident.

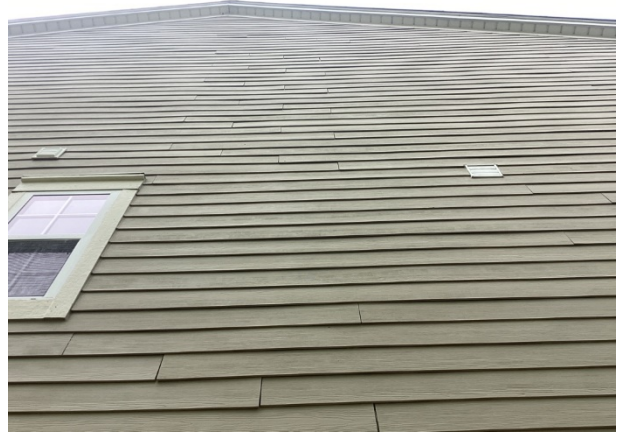
Siding deflection (479 Norwich shown)

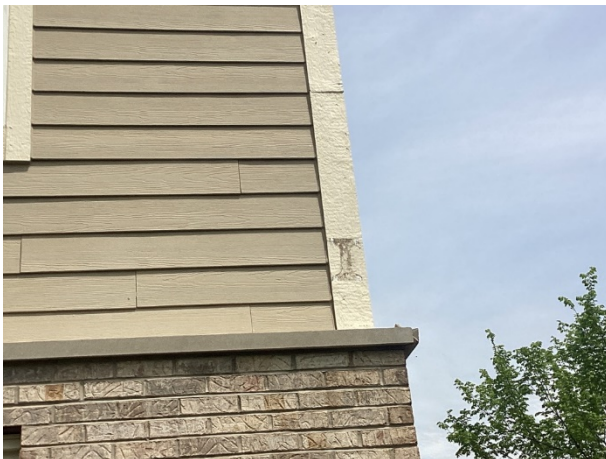
Finish deterioration

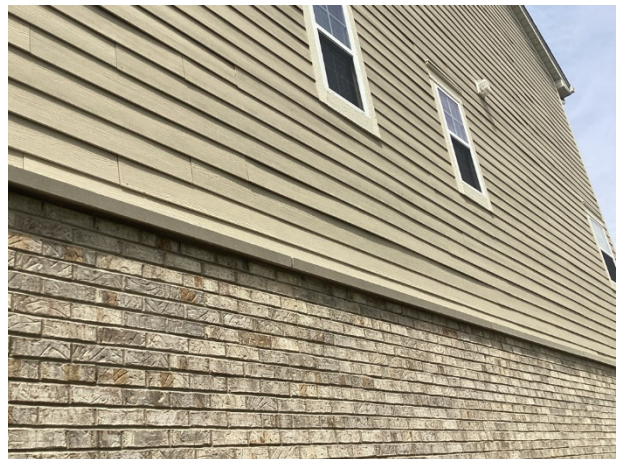
Siding deflection (640 Belmont shown)

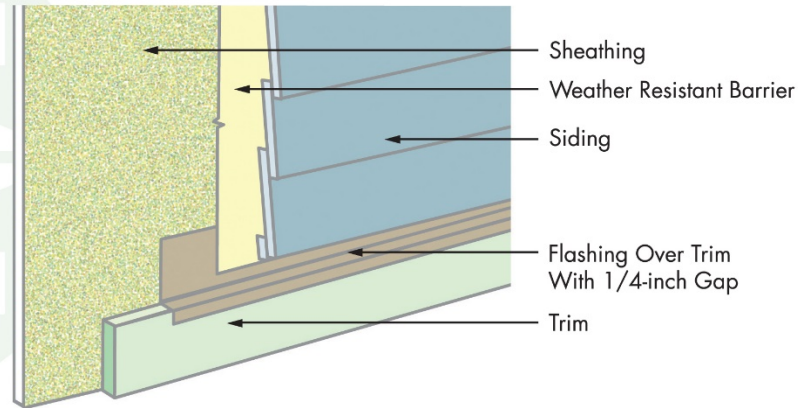
FIBER CEMENT SIDING DETAIL

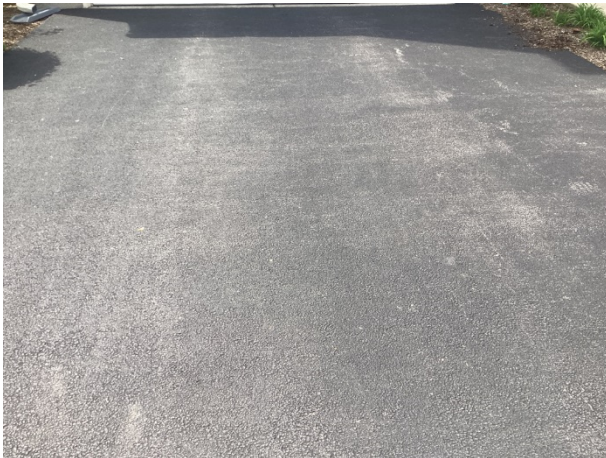
History: Repaved in 2014.

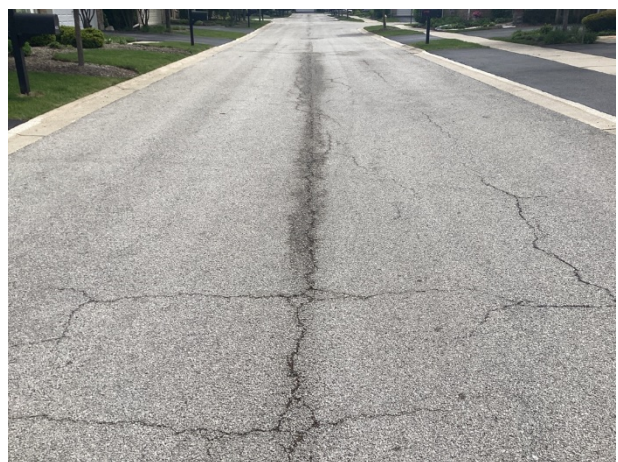
Street overview – note centerline cracks

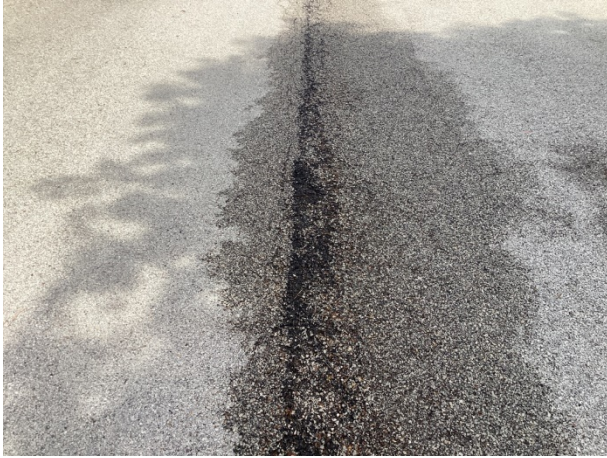
Centerline deterioration

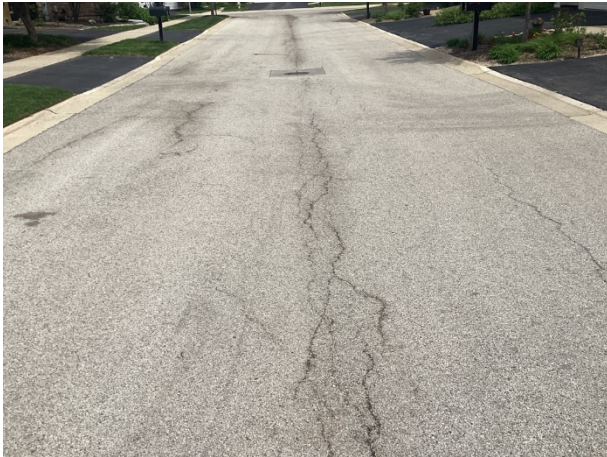
Street centerline cracks

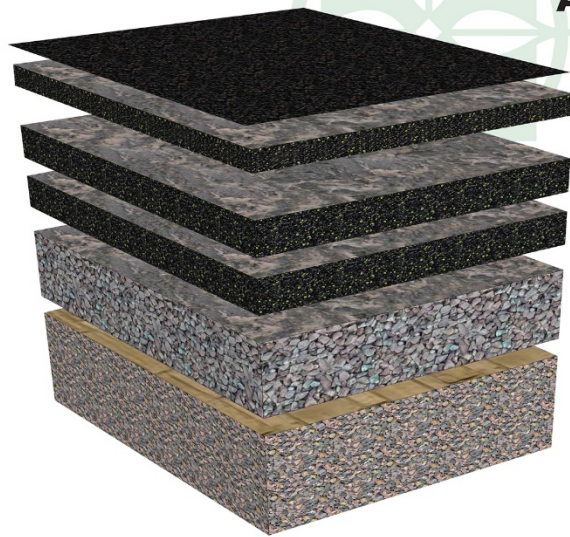
Component Detail Notes: The initial installation of asphalt uses at least two lifts, or two separate applications of asphalt, over the base course. The first lift is the binder course. The second lift is the wearing course. The wearing course comprises a finer aggregate for a smoother more watertight finish. The following diagram depicts the typical components although it may not reflect the actual configuration at Forest Glen:

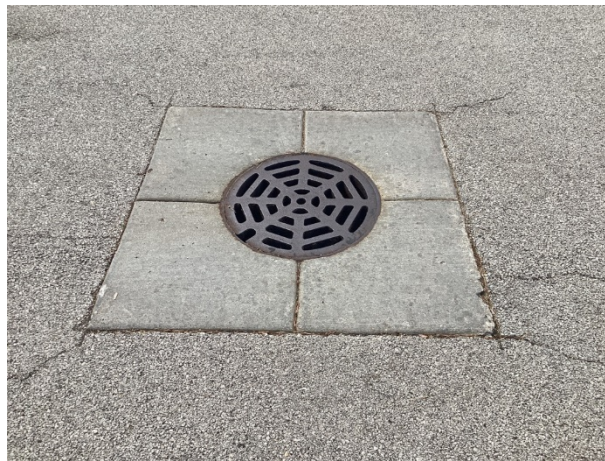
Condition: Fair overall with evidence of previous repairs.

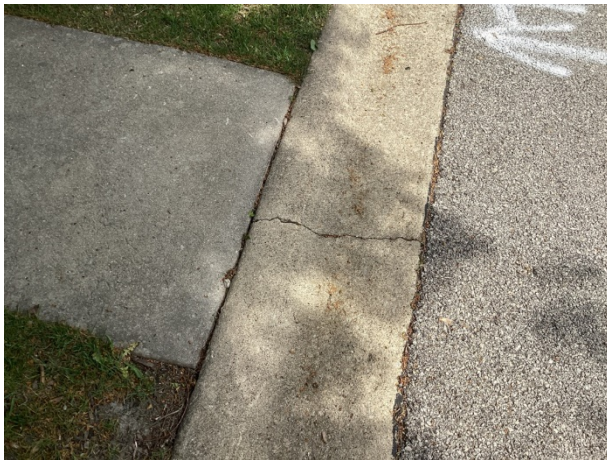
Curb and gutter crack

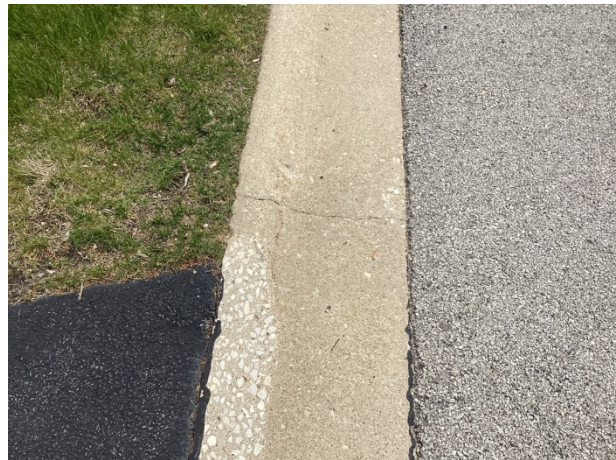
Curb and gutter crack

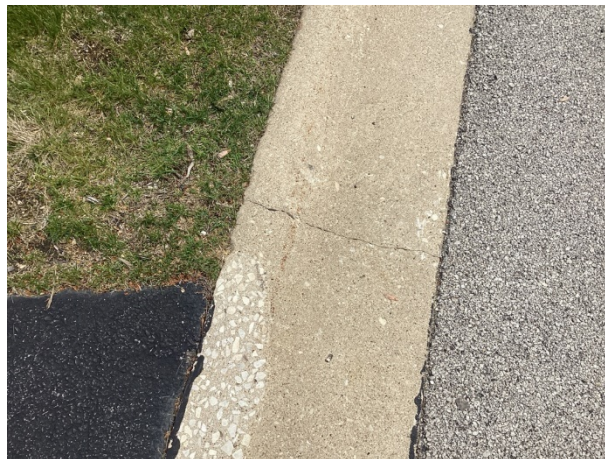
Curb and gutter crack

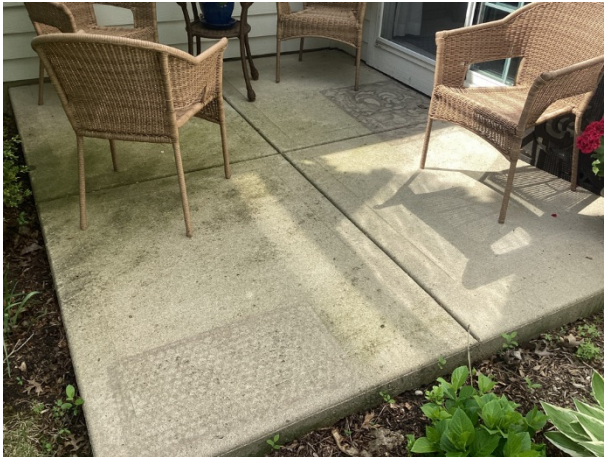
Condition: Fair overall with isolated cracks and trip hazards evident.

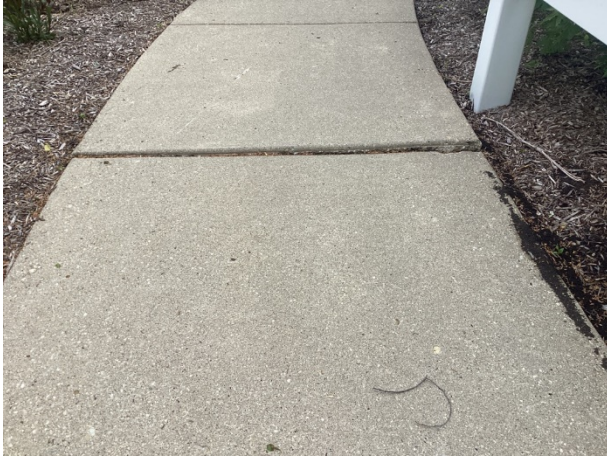
Sidewalk trip hazard

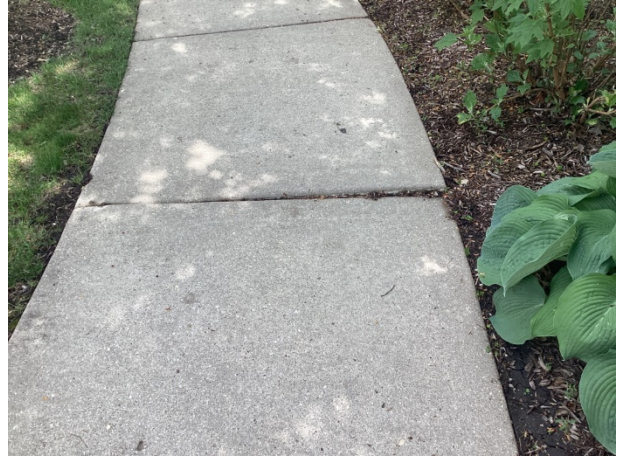
Sidewalk trip hazard

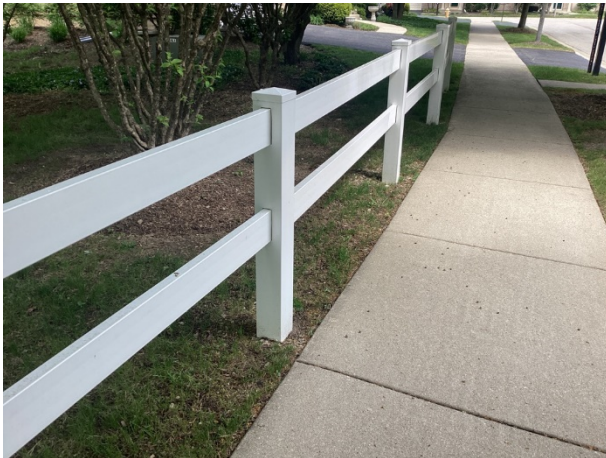
Vinyl fence overview

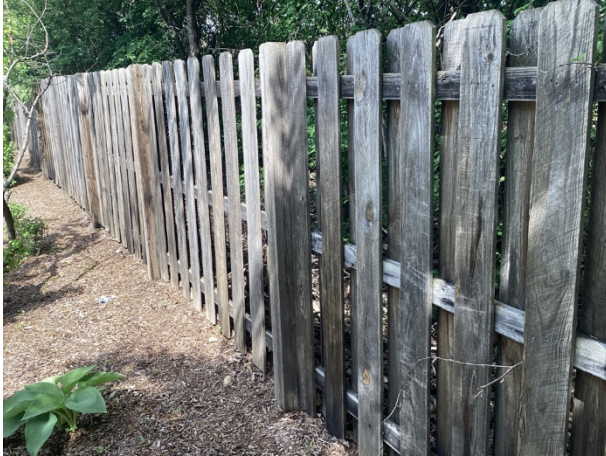
- 750 linear feet located at the north perimeter of the property replaced in approximately 2017 in fair overall condition with isolated panel warp and areas of replaced sections due to damage from construction at the neighboring property. The Association informs us they may desire to upgrade the fence to improve privacy.
- 240 linear feet of patio privacy fences in fair to poor overall condition with systemic lean evident.

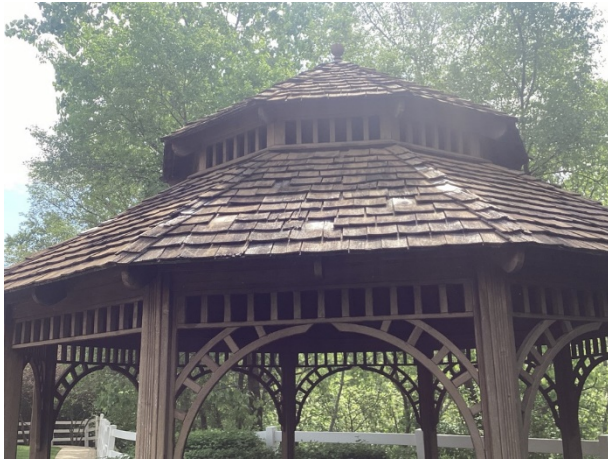
Condition: Fair to poor overall with isolated missing shingles and periodic organic growth, wood rot and deterioration evident.

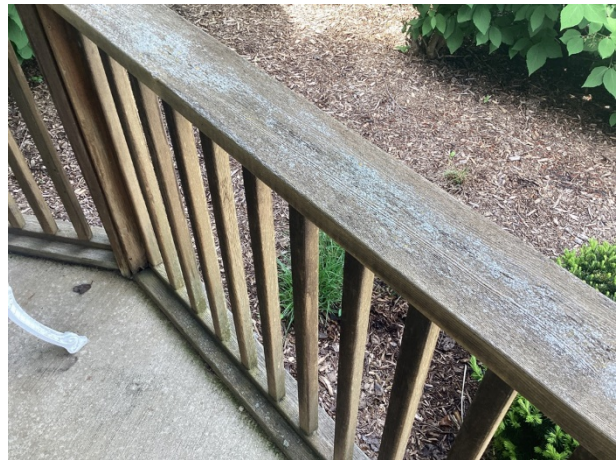
Railing – note organic growth

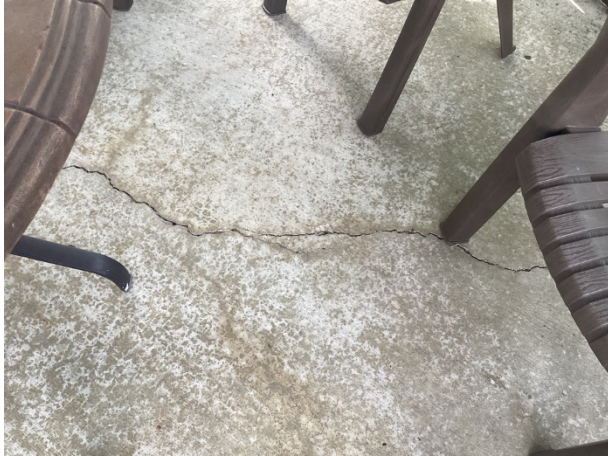
Concrete deck cracks

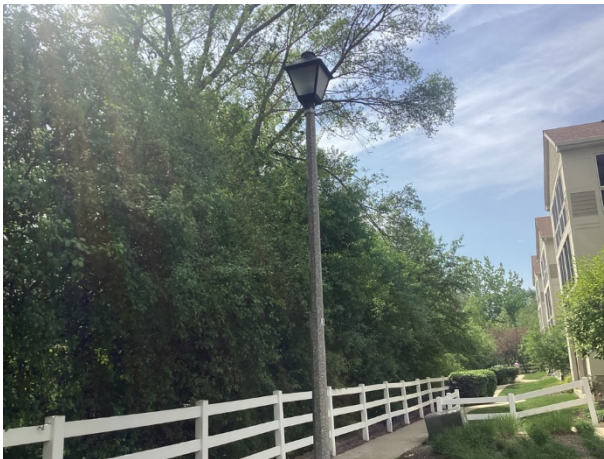
Light pole and fixture

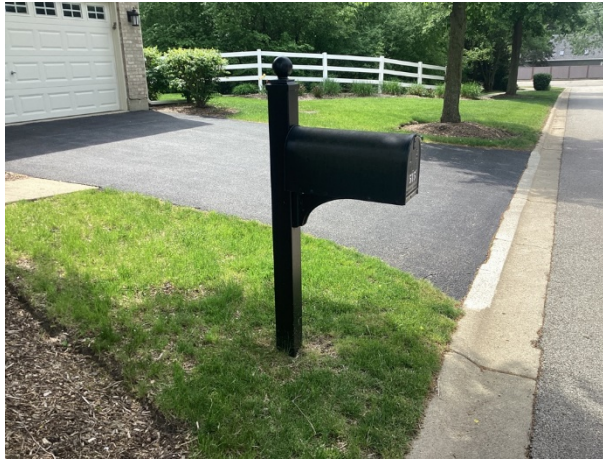
Condition: Good to fair overall

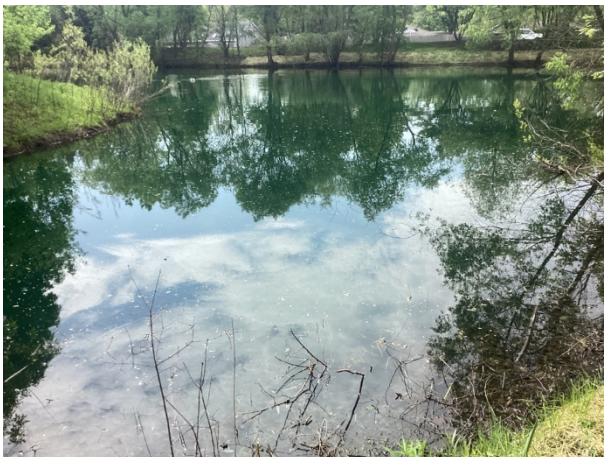
Condition: Fair overall with isolated sediment accumulation evident.

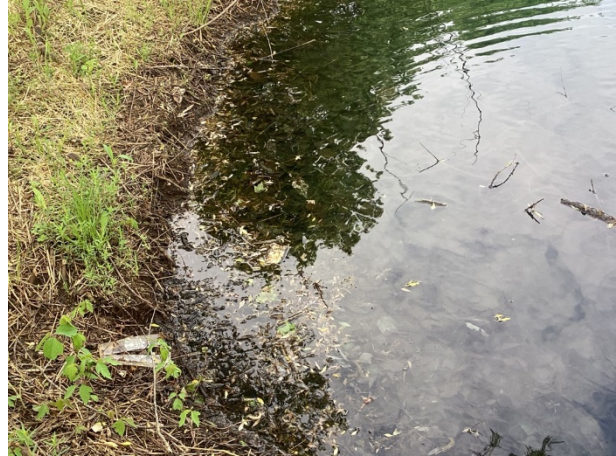
Sediment accumulation

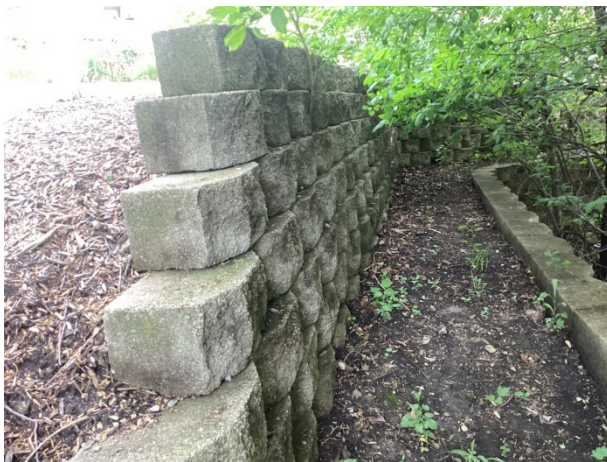
Retaining wall overview

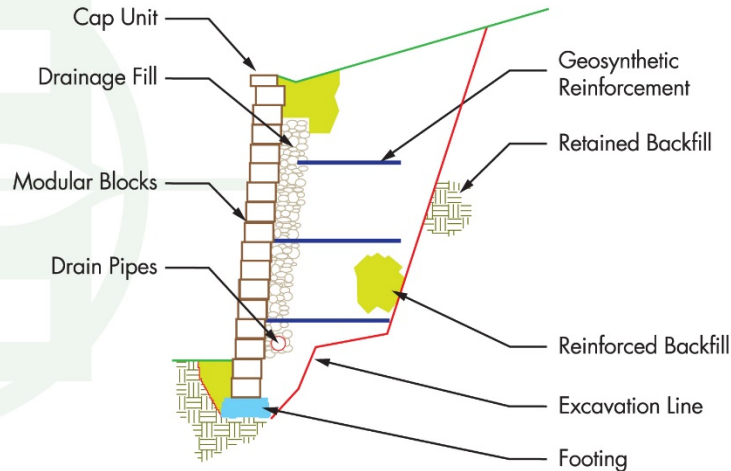
MASONRY RETAINING WALL DETAIL

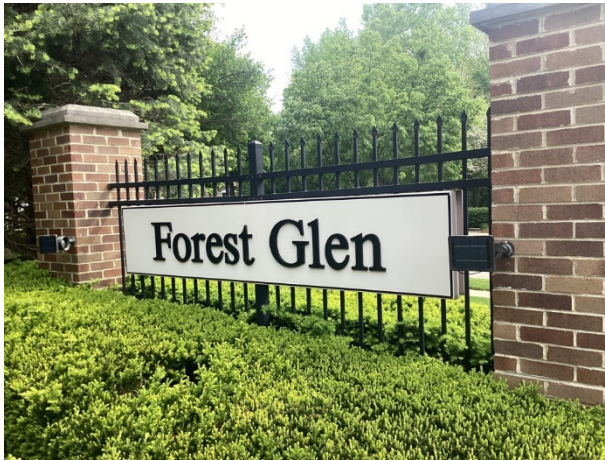
Condition: Fair overall

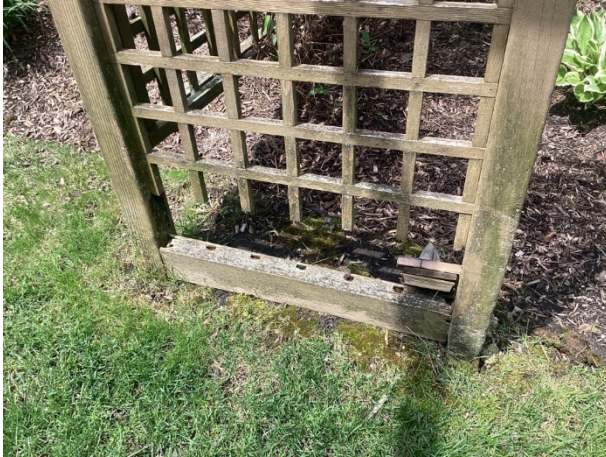
Condition: Fair to poor overall with isolated missing pickets and deterioration and periodic organic growth

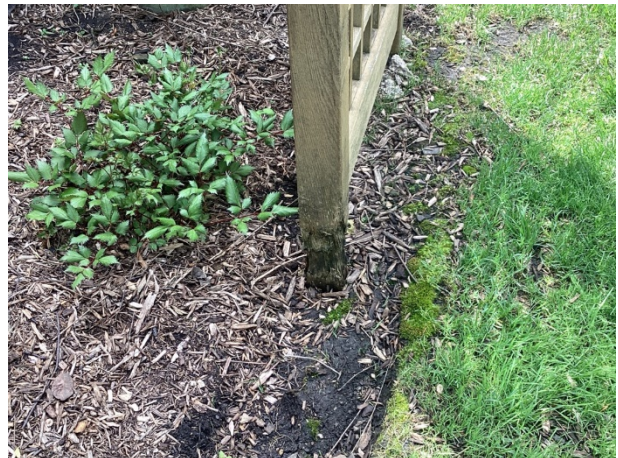
Trellis overview – note sag in center

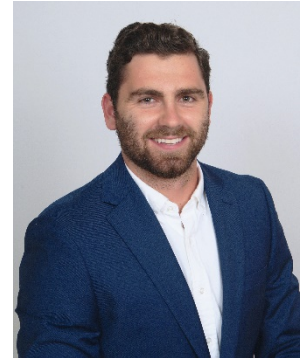
The following is a partial list of clients served by Reid Nelson demonstrating his breadth of experiential knowledge of community associations in construction and related buildings systems.
